Refurbishment of Axial & Radial Type Turbine Shaft Seals Using Elastomeric Polymers to Extend Wear Life and Reduce Leakage Rates

Greg Auger, P.Eng ^a and Dr. Goujon (Gary) Ren, P. Eng ^b

a. *Hydro Business Unit Manager - Thordon Bearings Inc., Burlington, Ontario Canada.*

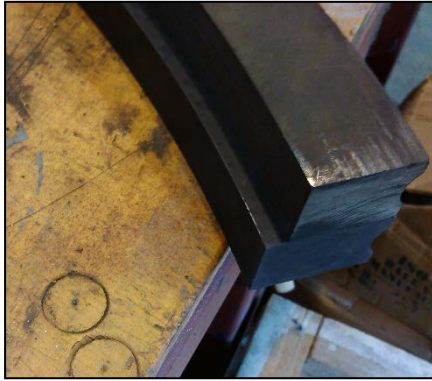
Fig 6 - Original Carbon Seal Segment

In 2016 Thordon Bearings began discussion with a customer operating a power station in New Zealand to discuss possible refurbishment of a radial shaft seal that was fitted with carbon segments. A total of six identical vertical Francis turbines were installed at the station, with each unit rated at 93MW at 92m of head, rotating at 166 rpm (sliding speed of 7.4 m/s at the seal face). The units were originally built and installed by General Electric in 1965, and have a shaft diameter of 850mm over the stainless steel sleeve fitted in way of the shaft seal.

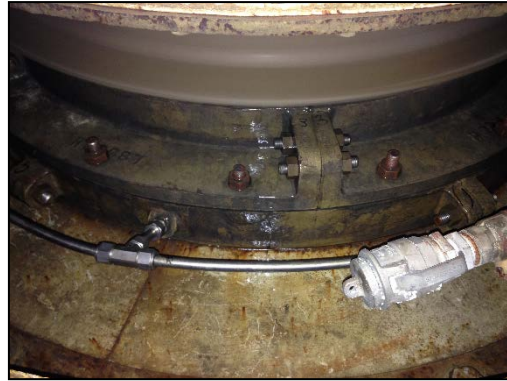
Fig 7 - Assembled Shaft Seal

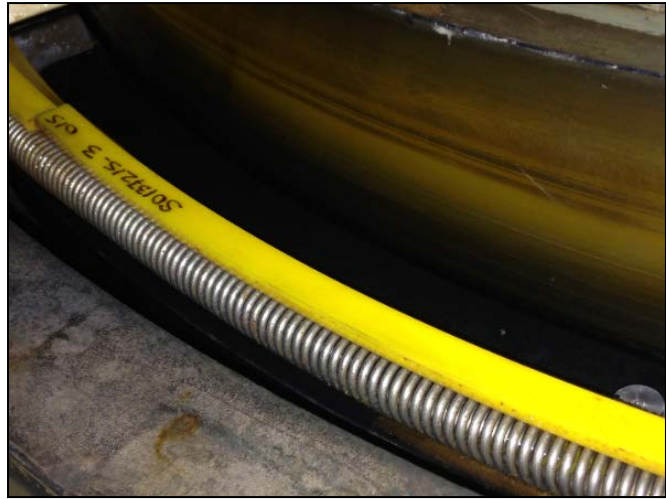
Fig 11 - New Garter Springs & Spring Holder (yellow)

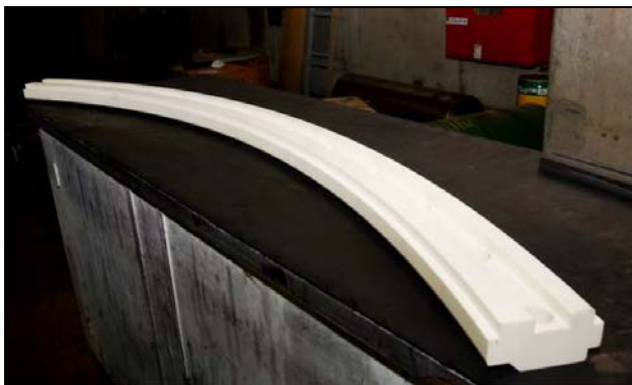
Fig 14 - New Thordon SXL Seal Segment

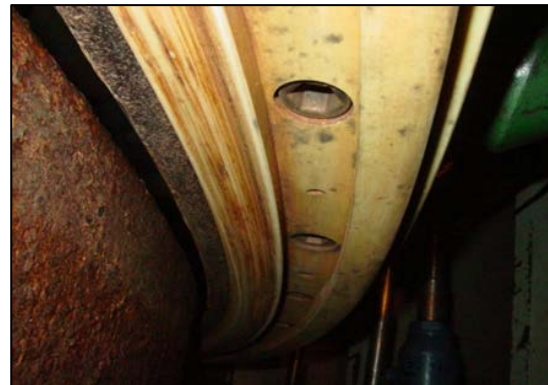
Fig 15 - Sealing Face - 1 year Inspection

After one year of operation, the turbine was taken apart for inspection. After opening the seal, the sealing face on the turbine water side was clean and since the machining marks were still visible there had been negligible wear if any. The sealing face on the leakage side however had several regions that appeared discolored (dark) and there were some film like material partially adhered / detached from the seal face. It was immediately suspected (incorrectly) that these were indications of overheating and sealing problems. Most of the discoloration and the adhering films however were removed with simple cleaning and the sealing surface then appeared very smooth. The brown coloured film substance taken from the sealing surface was sent to Thordon for composition study. Thordon tested the content of substance and it was determined 60% of it was organic from the process water and 40% was SXL material removed from sealing surface. Precise dimensional measurements of the seal were recorded and only one small section had worn by 0.1mm; wear in other areas was negligible. Accordingly, it was predicted that the seal should work for the 20 year requirement.

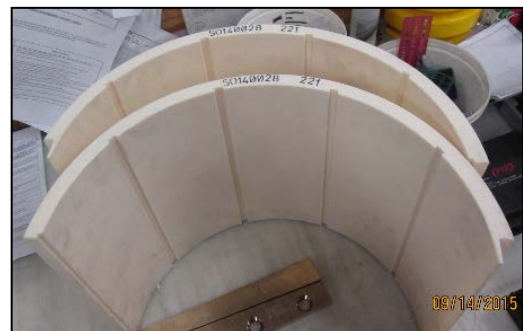
Fig 20 - Thordon SXL Bearing Insert

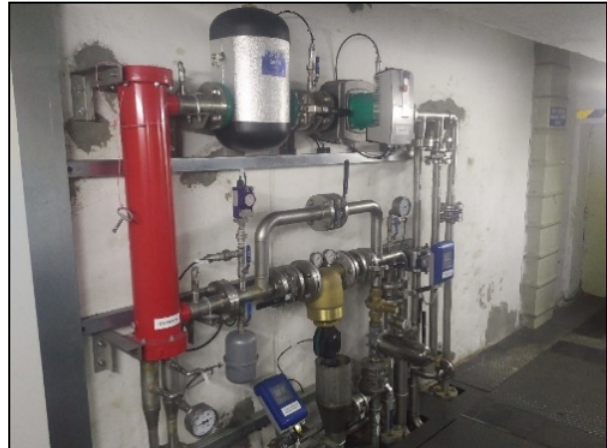
Fig 22 - Bearing & Seal Water Filtration System
