Industry: Thermal Power Generation

End User: Termo Electrica Barranquilla SA (TEBSA), Colombia

Application: Gate Filter Strainer for Water Supply to Cooling System

Thordon Grade: ThorPlas-Blue

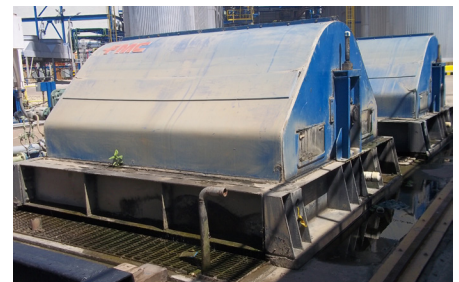
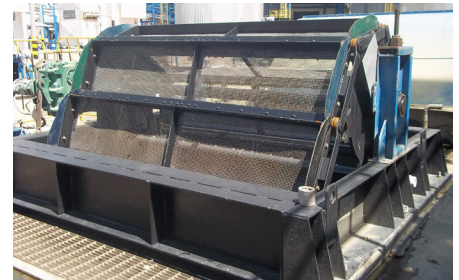
Strainer Filters

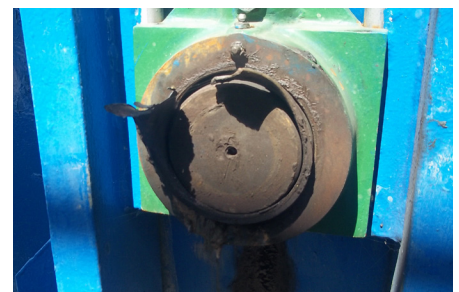
With the abrasives and grease combined, the bronze bearings were experiencing excessive and accelerated wear resulting in the bronze bearings needing to be replaced every three months.

*Initial situation of bronze bearing
after 3 months of operation*

Given the high costs to frequently replace the bearings, and the amount of downtime they were experiencing, TEBSA started to look for alternative solutions that were both efficient and reliable. When they contacted Thordon to ask about our robust bearing solutions, they were referred to our authorized distributor in Colombia, Delta Marine and River Services (DMARs). Representatives from DMARs visited the facility to analyze the bearing failure and to discuss the best solutions. They recommended Thordon's ThorPlas-Blue as it can tolerate the load required in this application and most importantly, it operates without grease and would therefore improve the system significantly.

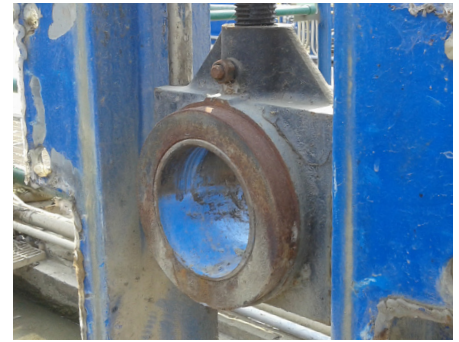
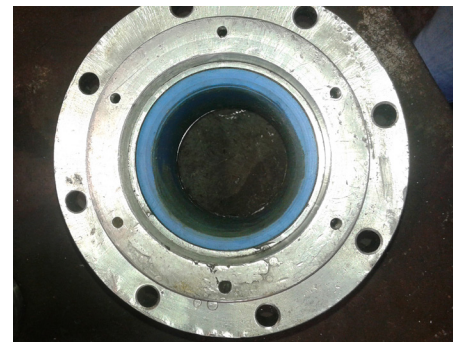
ThorPlas-Blue bushing after 2.5 years of operation

ThorPlas-Blue was installed in July 2014 and the system has been considerably more reliable since ThorPlas-Blue was fitted. Where the bronze bearings needed to be changed every three months, after two and a half years the ThorPlas-Blue bearings were still in amazing shape and showed only 1mm (0.039in) of wear. TEBSA also saved a significant amount of money by eliminating downtime associated with bearing failure.

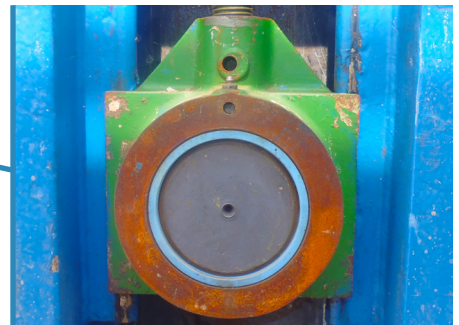
ThorPlas-Blue bearing installed

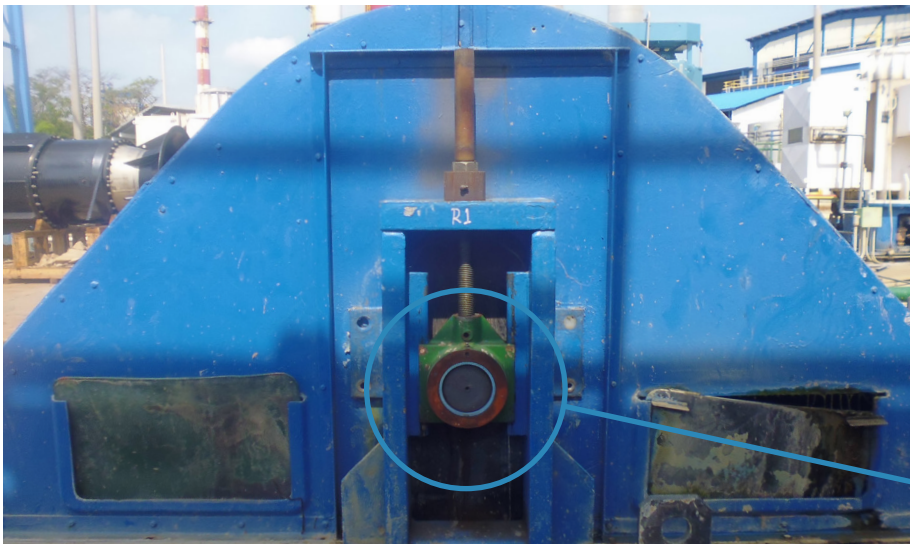
ThorPlas-Blue bearing after installation

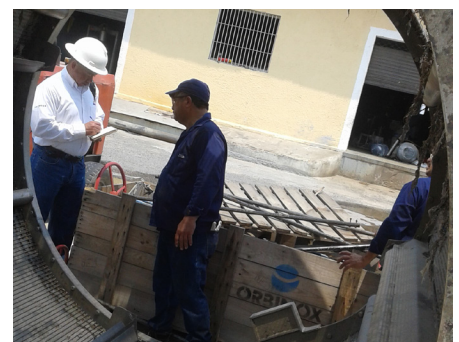
Field visit gathering information for bushing sizing
