THORDON SXL GUIDE BEARING ELIMINATES RISK AT THE STAR LAKE GENERATING STATION

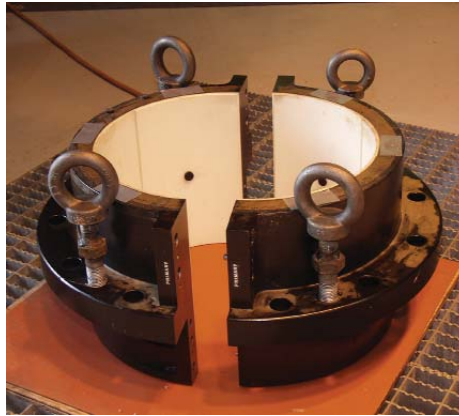
Thordon SXL Main Guide Bearing ready for installation at Star Lake

Working with Thordon's engineers, however, the decision was made to design and fabricate the bearing in two halves. "We simply took the two halves and bolted them together around the shaft," says Conlon. "Once the Thordon bearing was in place, it was positioned with a constant annulus around the shaft."
